## NEAR MISS. NON FERROUS WAREHOUSE

02/01/19

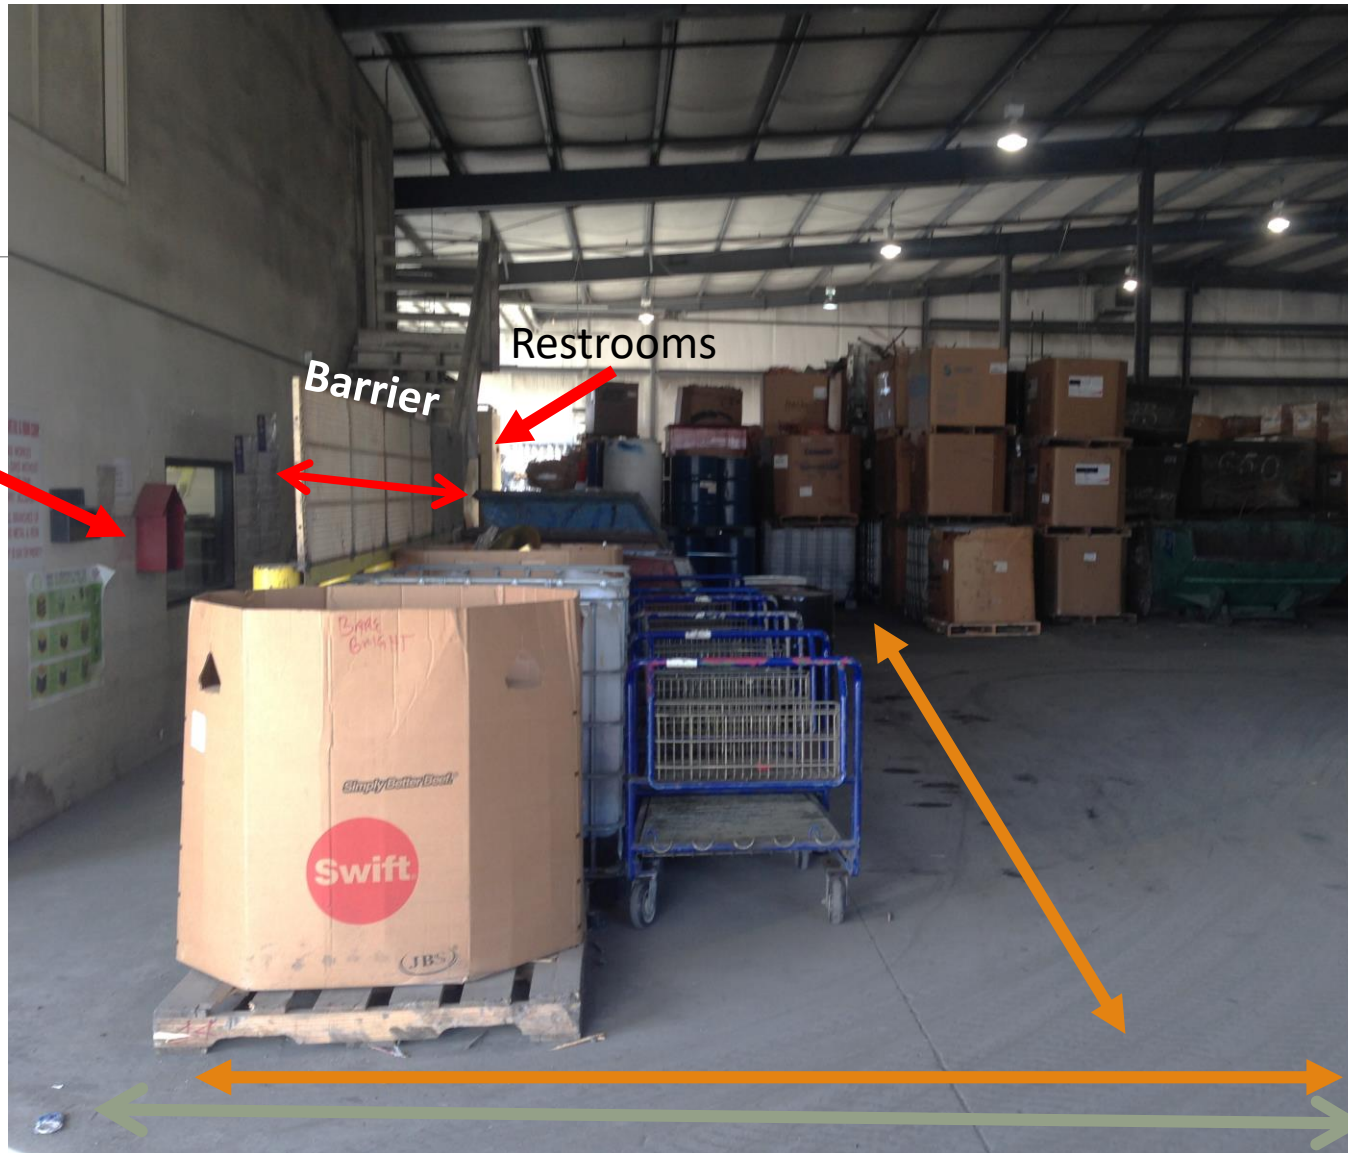
## INITIAL DESIGN

Access to  
time clock

↔ Forklift traffic  
→ Pedestrian traffic

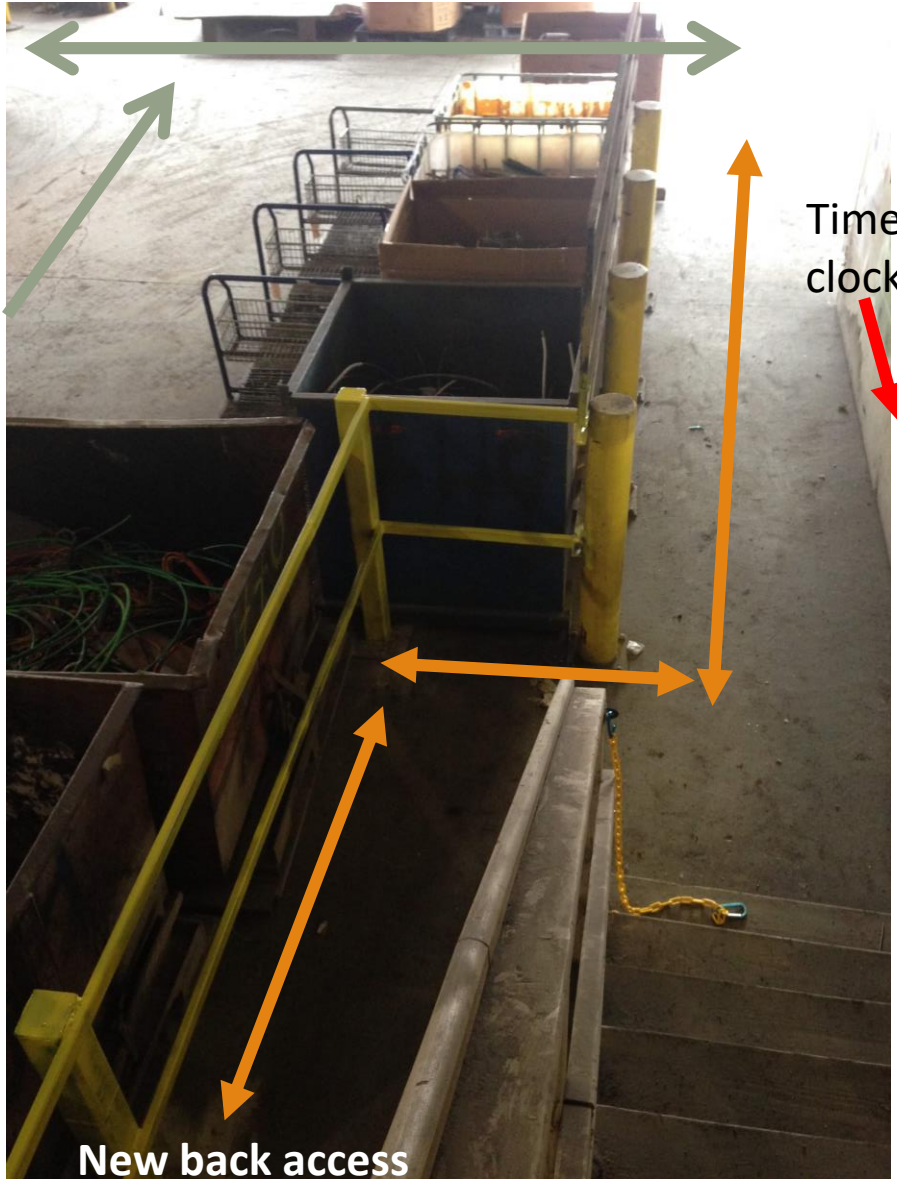
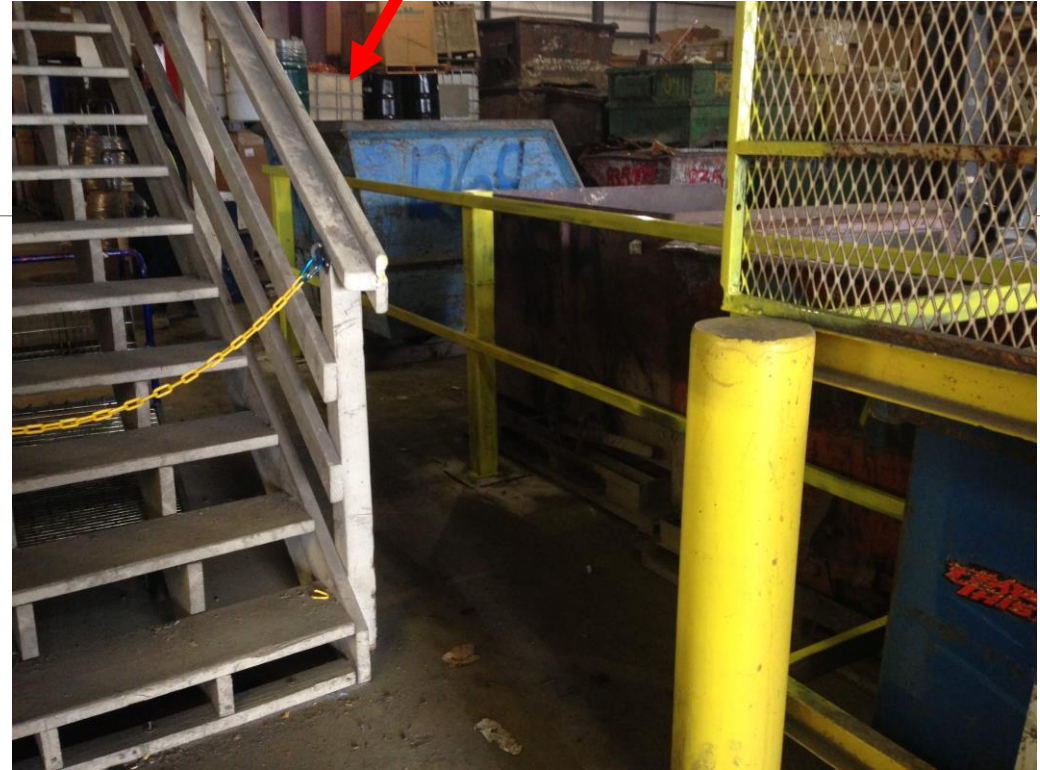
## FINAL DESIGN

## New back access

- Consulted employees for needs and ideas
- Opened back access.
- Designated and protected walkway for pedestrians.
- Direct access to Restrooms (back of the building)
